시험 성적서 TEST REPORT

성적서 번호 Report No.		ICRT-TR-R180198-0A	
신청자 Client	기관명 Name	KG AUTO CO.,LTD	
	주소 Address	9, Sinheung-ro 420 beon-gil, Bucheon-si, Gyeonggi-do	
시험대상품목 Sample description		Wireless remote controller	
모델명 Type designation		KG-R08AAAT	
정격 Ratings		-	
시험기간 Date of test		2018. 08. 13 ~ 2018. 08. 16	
시험방법/항목 Test Method/Item		IEC 60529 : 2013 (IP65)	
시험결과 Test Results		Reference to see Table 4)	
확인 Affirmation	작성자 Tested by	기술책임자 Technical Manager	
	성명 권상혁 Name S. H. Gwon	(서명) (Signature)	성명 이우범 Name W. B. Lee (서명) (Signature)

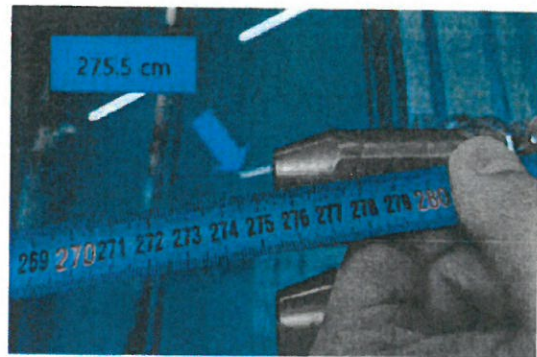
Figure 13) Photo of the specimen set up
(Distance from nozzle, Enlarge)

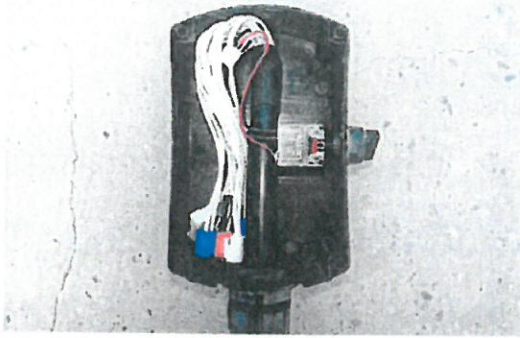
Figure 18) Photo of the specimen after the test
(IP6X, #1)

Test item	Test result	Note
IP6X	No dust penetration inside the tester	Visual inspection and operation confirmation
IPX5	No water penetration inside the tester

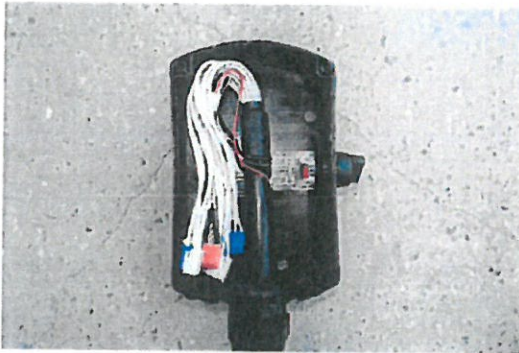
Figure 20) Photo of the specimen after the test
(IPX5, #1)

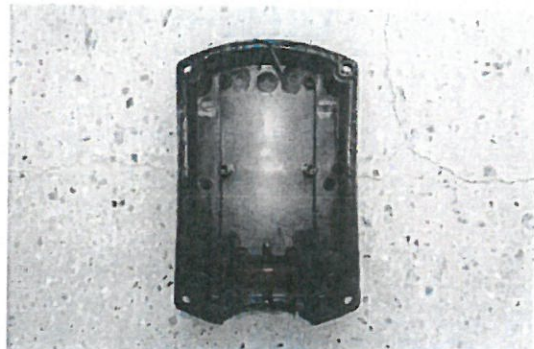
Figure 21) Photo of the specimen after the test
(IPX5, #2)
